APPLICATION UNDER SECTION 34 OF THE NATIONAL HERITAGE RESOURCE ACT (25 OF 1999)

ATHLONE POWER STATION DECOMMISSIONING

May 2025  
Sec34 V3

Prepared by Hearth Heritage: Emmylou Rabe Bailey  
for Zutari (Pty) Ltd on behalf of The City of Cape Town

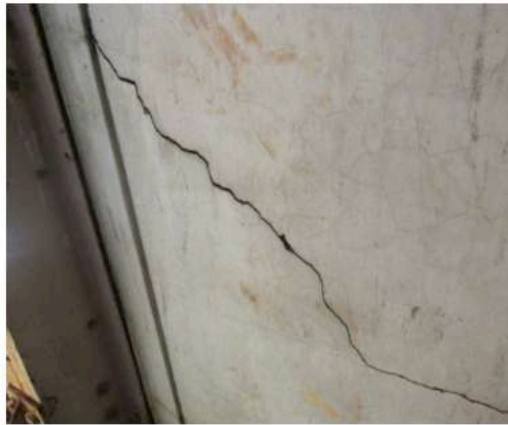
**IMAGE OF MASONRY CRACKED WALL ON THE NORTH-WEST AND NORTH-EAST CORNER TO BE REPAIRED AND REPLASTERED**

(ALLOW APPROXIMATELY FOR 25 m OF CRACKS)

CONCRETE CRACKS TO BE REPAIRED AS PER METHOD STATEMENT AND DETAILS ON DRAWING SS-0004.

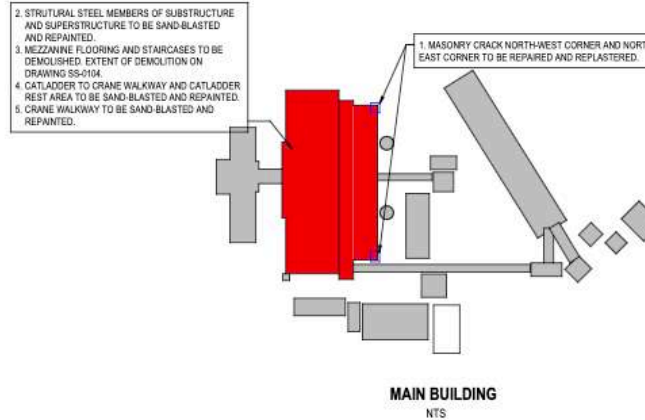
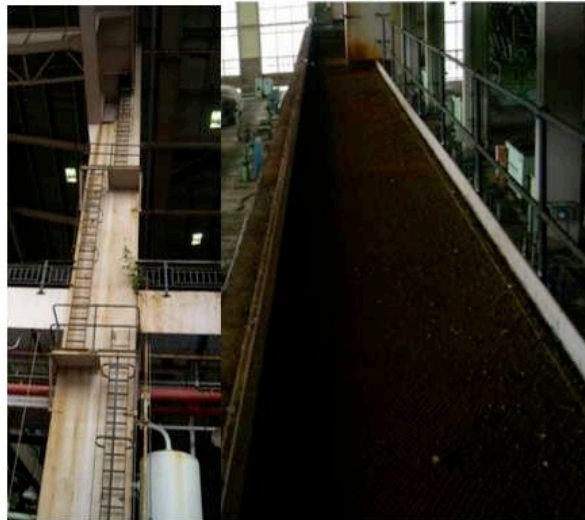
**IMAGE OF CORRODED CATLADDER, CATLADDER RESTING AREA AND WALKWAY NEXT TO CRANE TO BE SAND-BLASTED AND REPAIRED**

(ALLOW APPROXIMATELY FOR 4 m² PAINTED AREA OF CATLADDER REST AREA)

SURFACE CORROSION TO BE REPAIRED AS PER METHOD STATEMENT AND DETAIL ON DRAWING SS-0007.

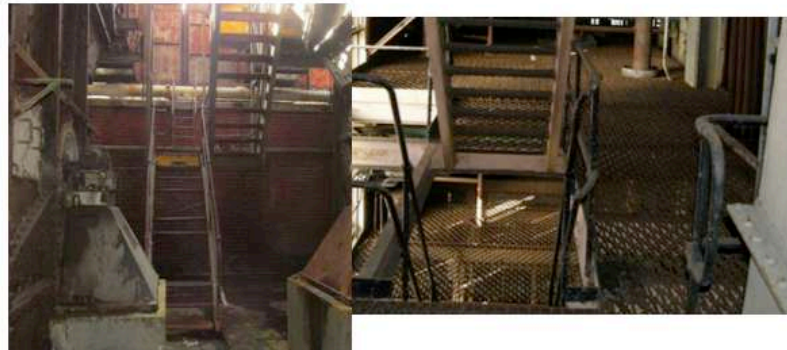
**IMAGE OF SEVERELY CORRODED MEZZANINE STAIRCASE AND FLOORING TO BE ALL BE DEMOLISHED**

DEMOLITION PROCEDURE AS PER METHOD STATEMENT. EXTENT OF DEMOLITION AREAS, REFER TO DRAWING SS-0104.

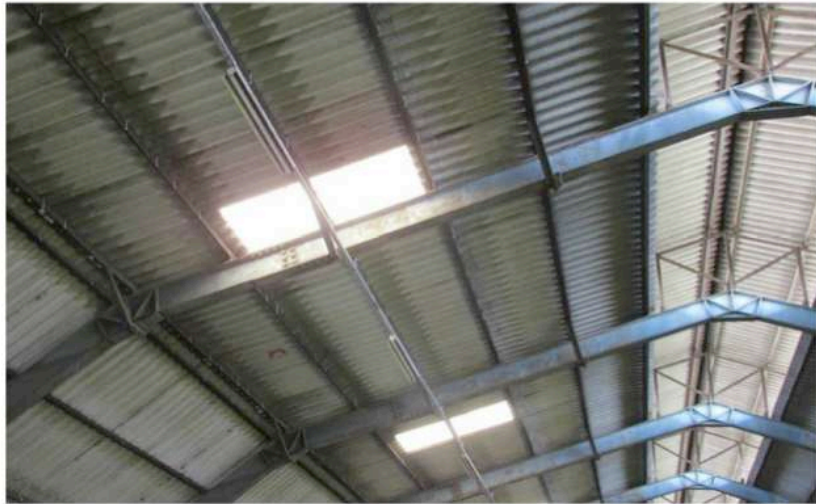
IMAGE OF ROOF STRUCTURAL STEEL MEMBERS TO BE SAND-BLASTED AND REPAINTED

(ALLOW APPROXIMATELY FOR 2800W<sup>2</sup> PAINTED AREA)

STRUCTURAL STEEL MEMBERS TO BE REPAIRED AS PER THE METHOD STATEMENT AND DETAILS ON DRAWING SS-007.

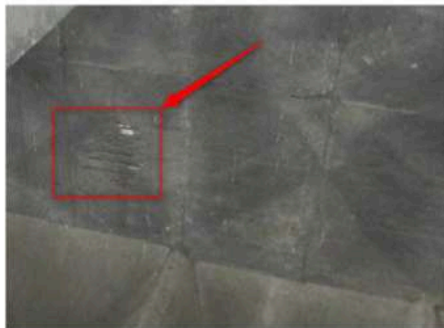
IMAGE OF CONCRETE OF INTERNAL WALL TO BE REPAIRED

(ALLOW APPROXIMATELY FOR 5% PER M<sup>2</sup> OF BEAMS AND WALKWAYS)  
(ALLOW APPROXIMATELY FOR 1% PER M<sup>2</sup> OF INTERNAL WALL)

CONCRETE SPALLING TO BE REPAIRED AS PER THE METHOD STATEMENT AND DETAILS ON DRAWING SS-005.

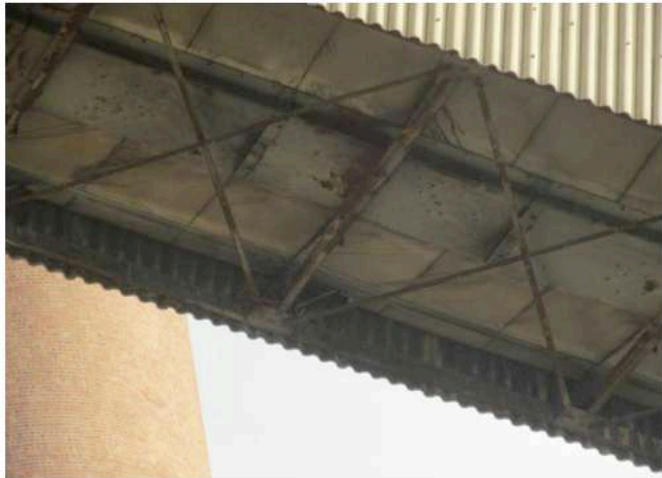
IMAGE OF SURFACE CORROSION OF STRUCTURAL STEEL MEMBERS UNDER COAL CONVEYOR TO BE SAND-BLASTED AND REPAINTED

(ALLOW APPROXIMATELY FOR 1000 m<sup>2</sup> PAINTED AREA FOR THE MAIN COAL CONVEYOR)  
(ALLOW APPROXIMATELY FOR 1000 m<sup>2</sup> PAINTED AREA FOR THE COAL CONVEYORS)

SURFACE CORROSION TO BE REPAIRED AS PER METHOD STATEMENT AND DETAILS ON DRAWING SS-007.

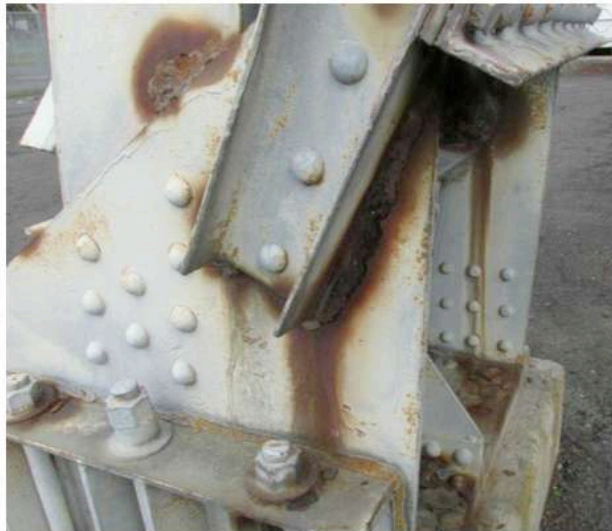
IMAGE OF STRUCTURAL STEEL SUPPORTS TO BE SAND-BLASTED AND REPAINTED

SURFACE CORROSION TO BE REPAIRED AS PER METHOD STATEMENT AND DETAILS ON DRAWING SS-007.

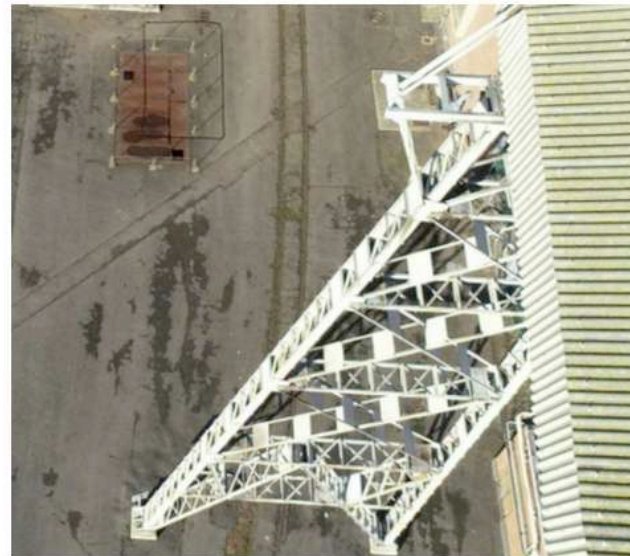
IMAGE OF STRUCTURAL STEEL MEMBER SUPPORTS TO BE SAND-BLASTED AND REPAINTED

SURFACE CORROSION TO BE REPAIRED AS PER METHOD STATEMENT AND DETAILS ON DRAWING SS-007.

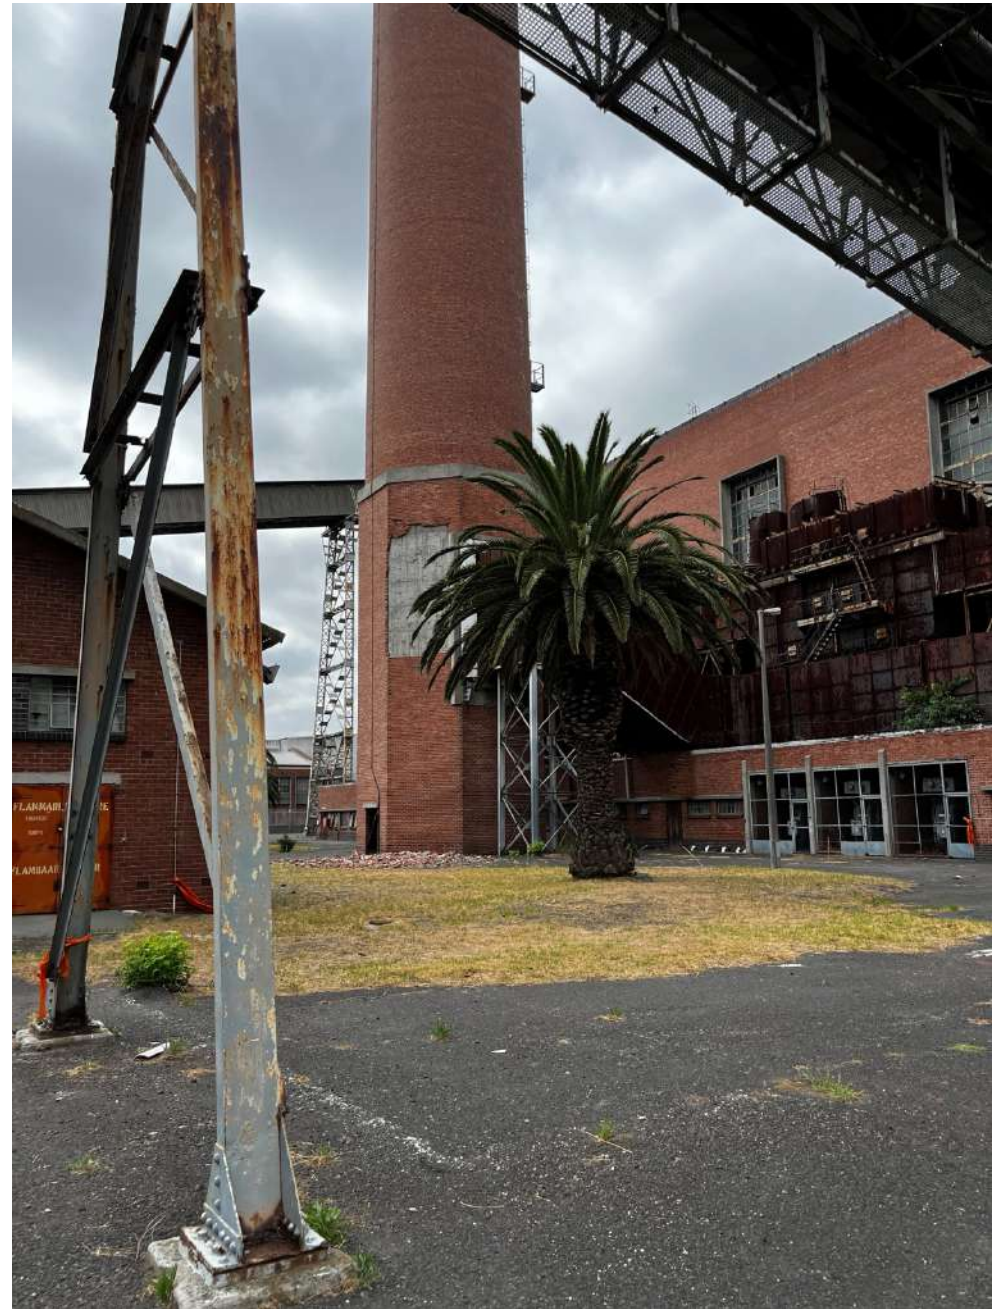
Figure 38: Chimney stack 2 with Ash conveyor overhead – note clad brick failure on chimney stack (Hearth, 2025)
