APPLICATION UNDER SECTION 34 OF THE NATIONAL HERITAGE RESOURCE ACT (25 OF 1999)

ATHLONE POWER STATION DECOMMISSIONING

May 2025  
Sec34 V3

Prepared by Hearth Heritage: Emmylou Rabe Bailey  
for Zutari (Pty) Ltd on behalf of The City of Cape Town

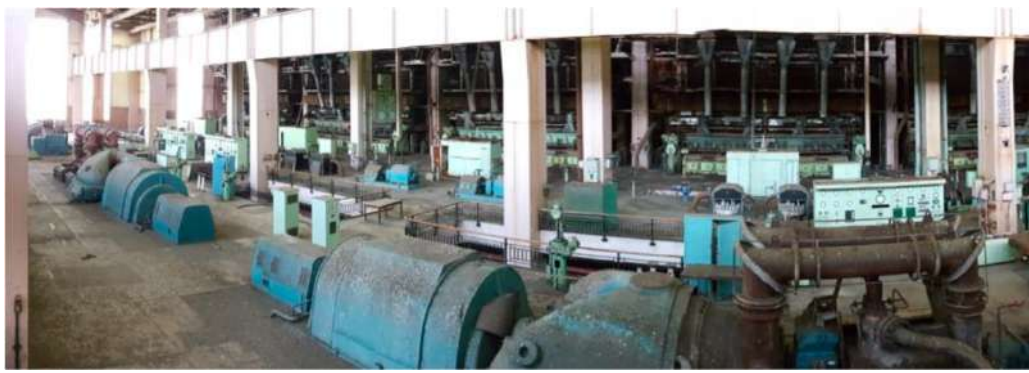
Figure 44: Turbine house flat roof (Esterhuyse, 2020)
