APPLICATION UNDER SECTION 34 OF THE NATIONAL HERITAGE RESOURCE ACT (25 OF 1999)

ATHLONE POWER STATION DECOMMISSIONING

May 2025  
Sec34 V3

Prepared by Hearth Heritage: Emmylou Rabe Bailey  
for Zutari (Pty) Ltd on behalf of The City of Cape Town

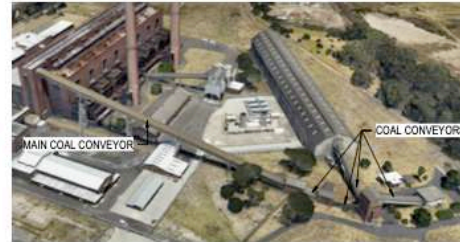
COAL CONVEYORS

IMAGE OF STRUCTURAL STEEL SUPPORTS TO BE SAND-BLASTED AND REPAINTED

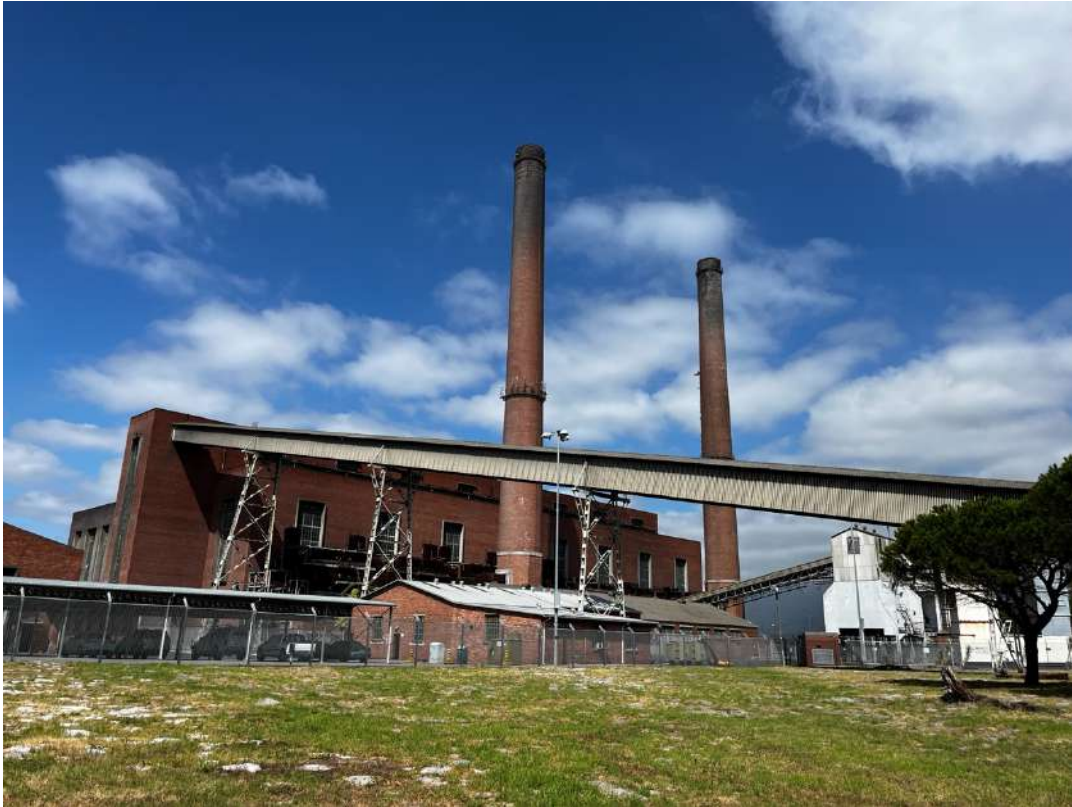
Figure 28: Turbine Hall, Boiler House, chimney stacks, store 2 and coal conveyor with ash bunker to the right.

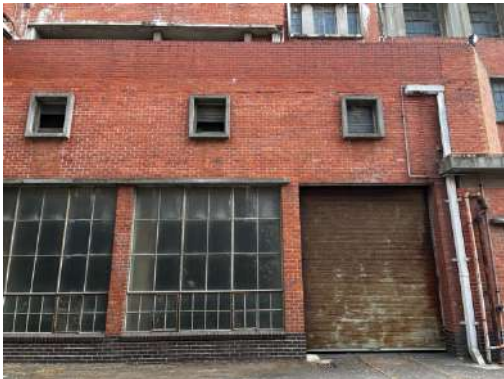
Figure 29: Turbine hall exterior with pump house annexe in front

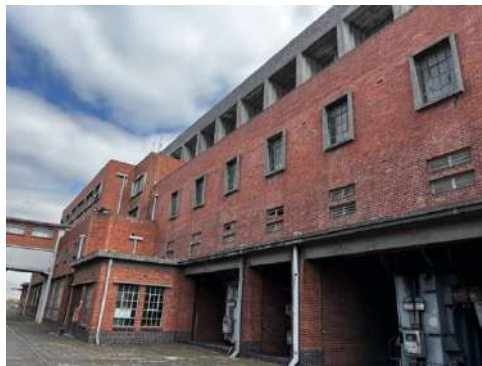
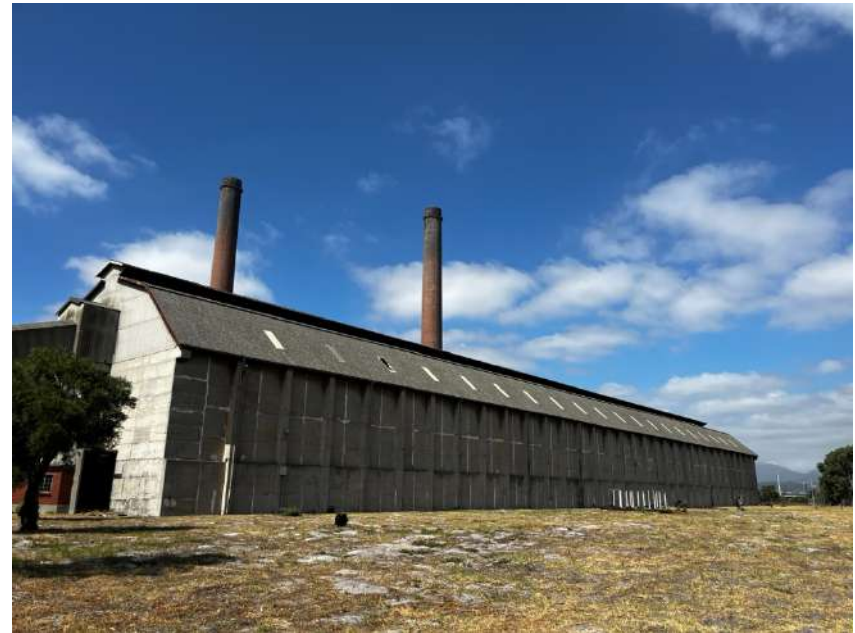
Figure 30: Coal bunker/ store

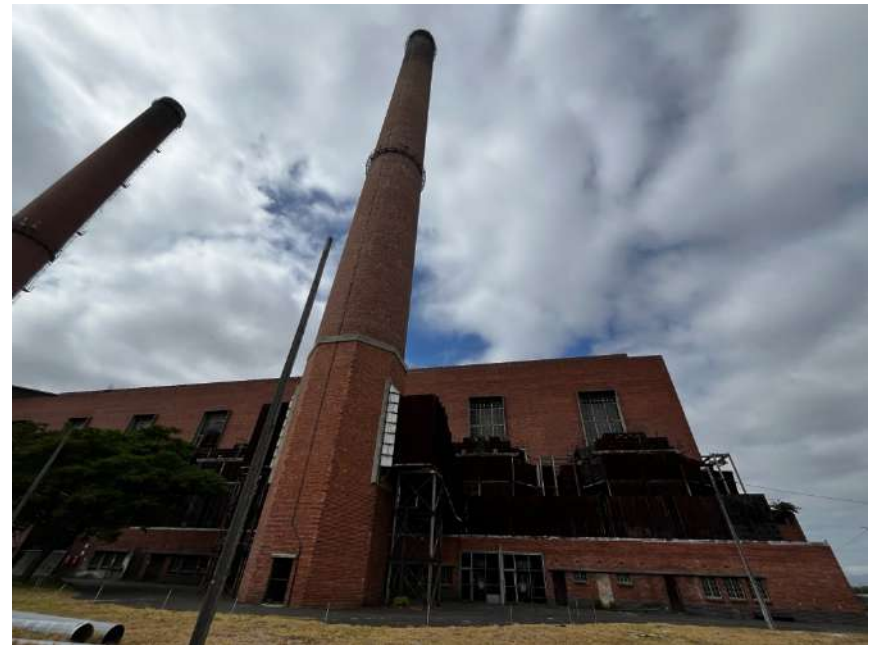
Figure 31: Boiler house with ash collectors on top and chimney stacks with turbine hall behind

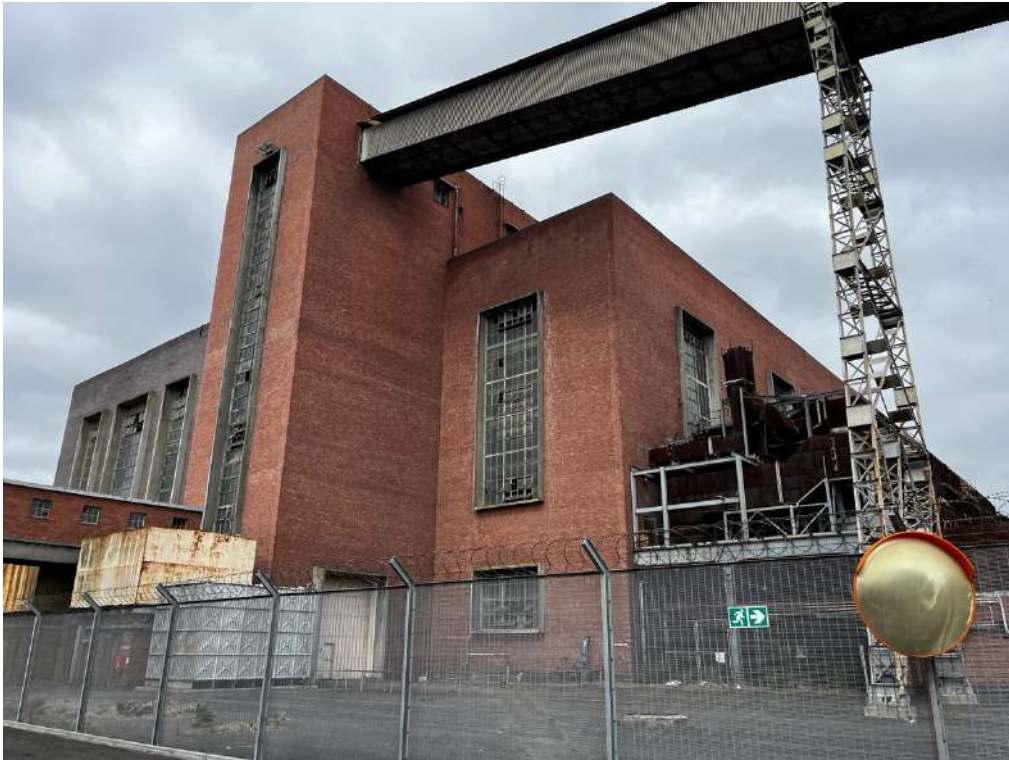
Figure 32: East elevation of the Main Building (Turbine Hall and Boiler House, showing Coal Conveyor structure (Hearth, 2025)

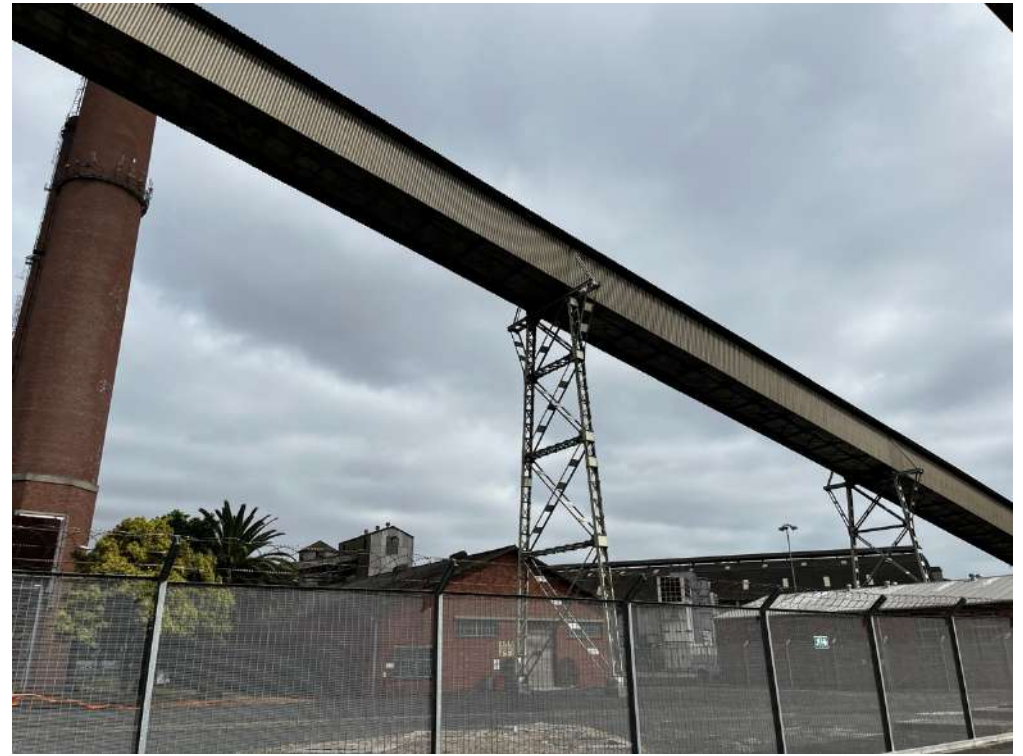
Figure 34: Coal Conveyor structure running between Boiler House and Junction Houses (Hearth, 2025)

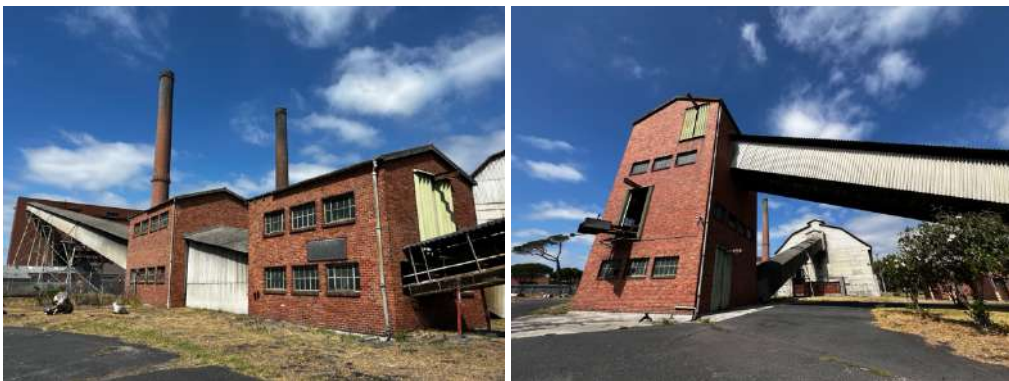
Figure 33: Junction House 2 & Weigher House (left) and Junction House 1 with Coal Conveyor with Coal Store behind (right) (Hearth, 2025)

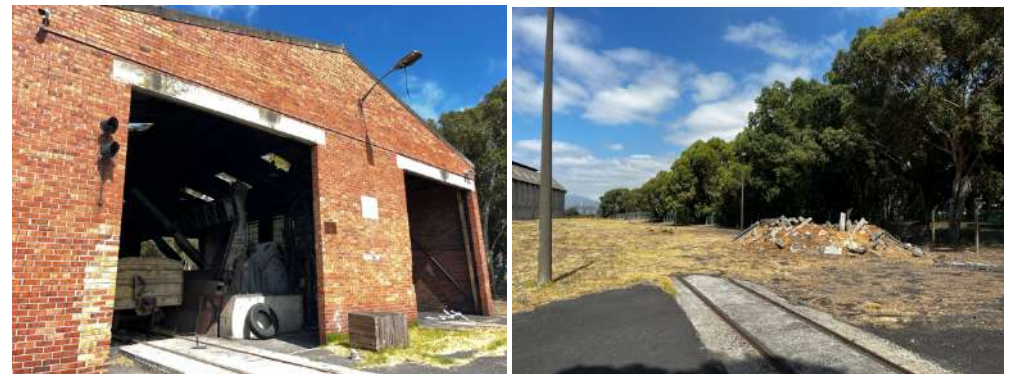
Figure 35: Tippler House with tippler truck inside (Left) and extant railway tracks to be retained (right) (Hearth, 2025)

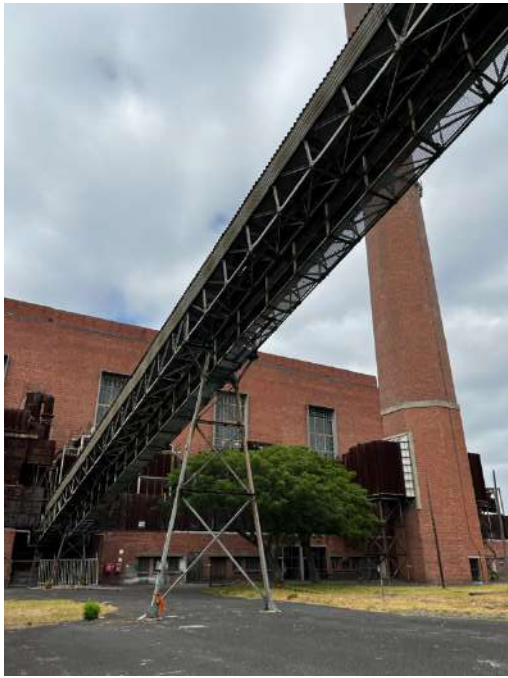
Figure 36: Ash Conveyor and Ash Plant (Hearth, 2025)

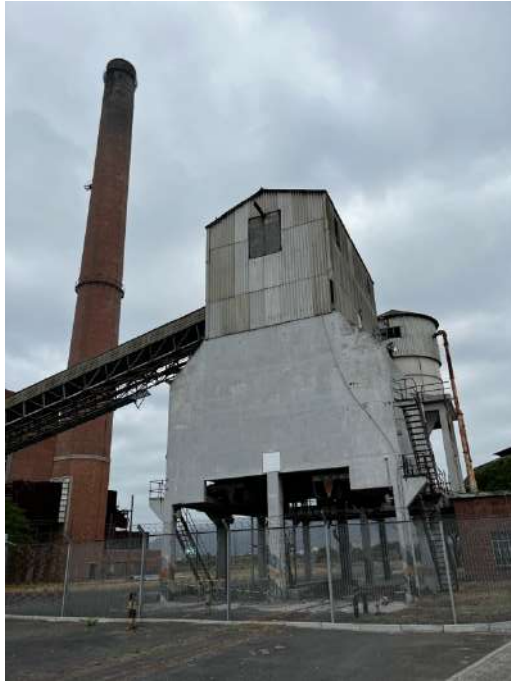
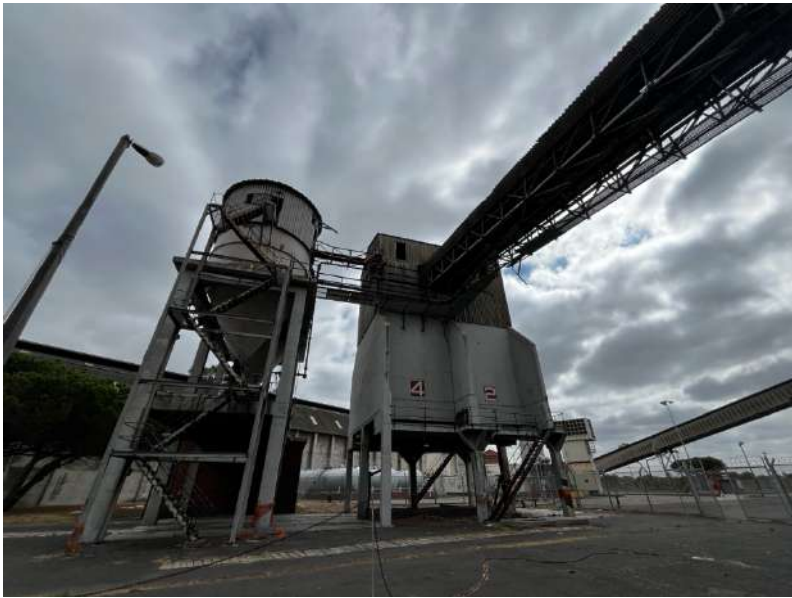
Figure 37: Ash Plant (Hearth, 2025)

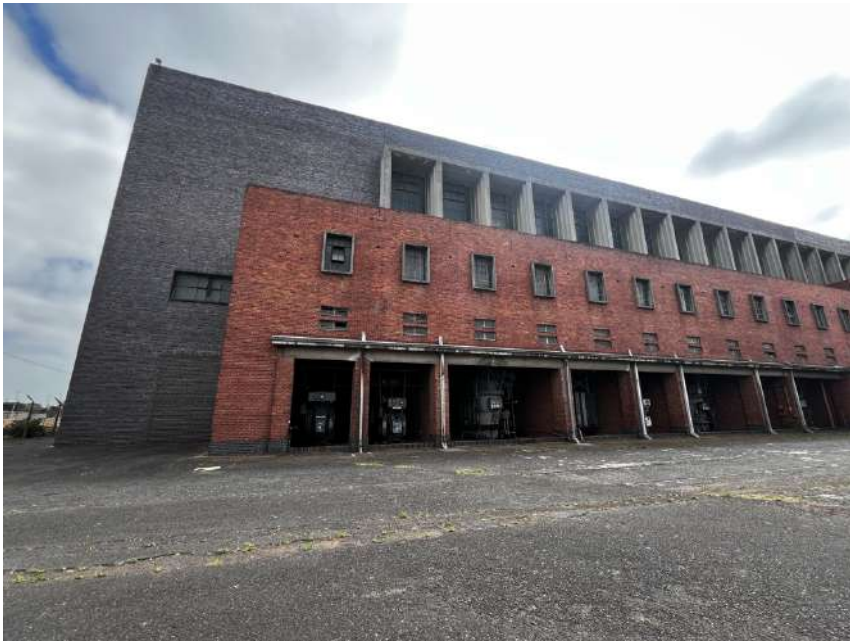
Figure 39: Turbine Hall with Cold Pump House and Electrical Annexe in front (Hearth, 2025)

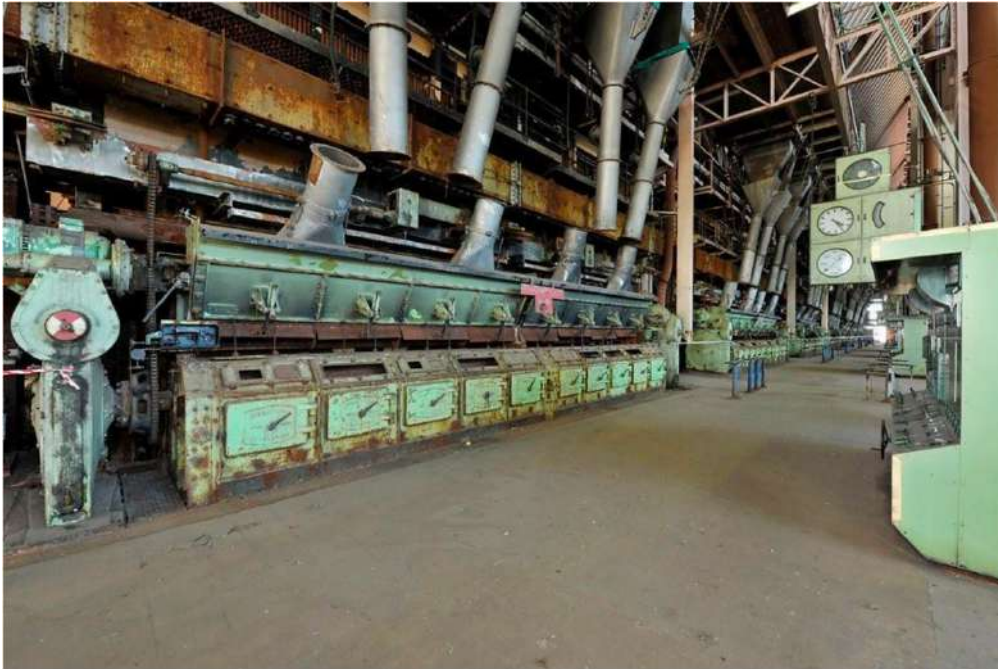
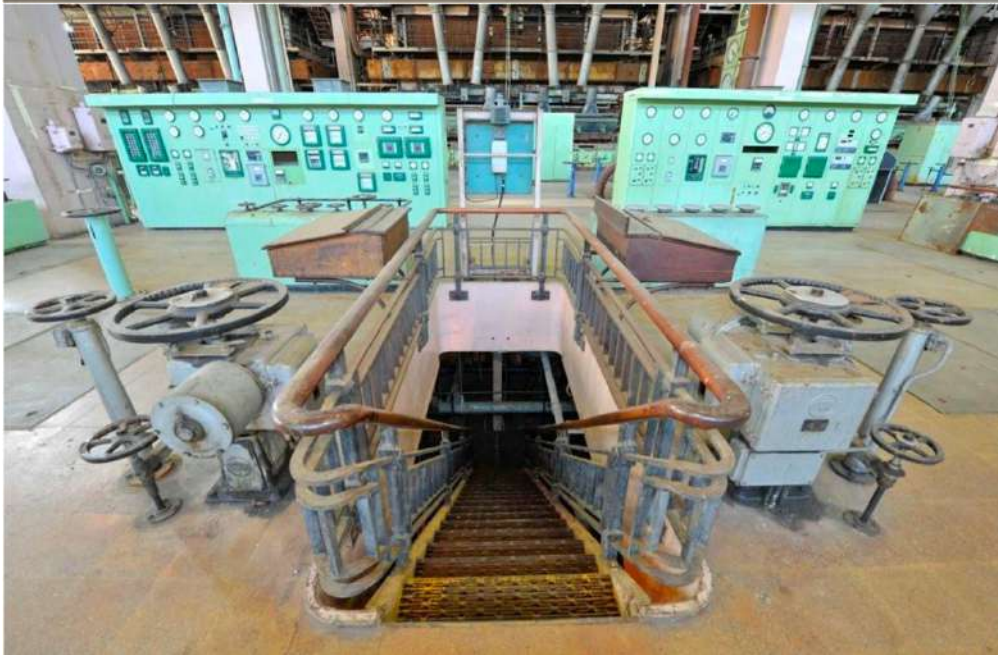
Figure 42: Interior photographs of Turbine Hall (2024)

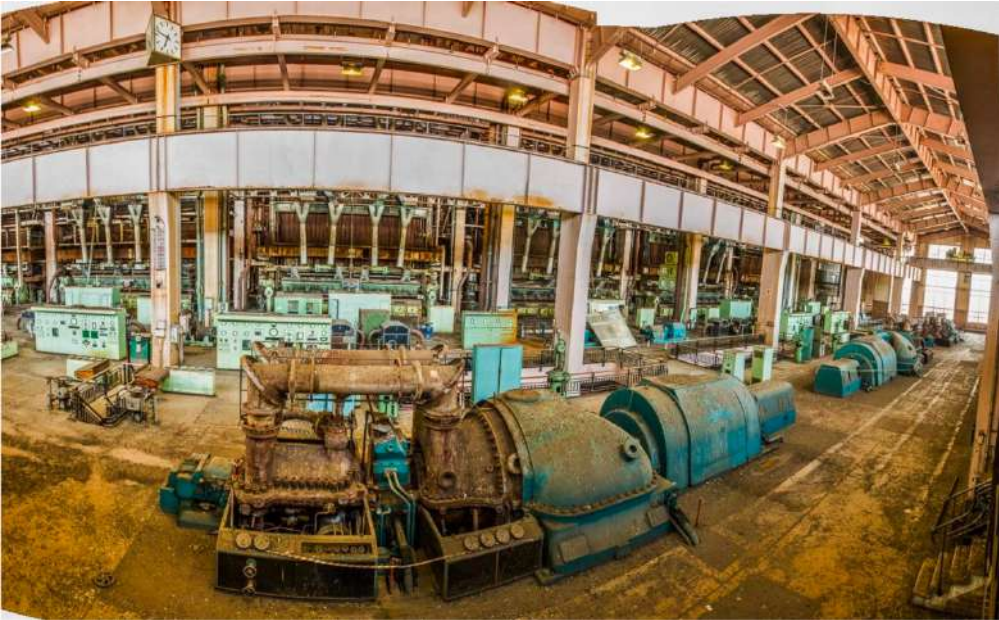
Figure 43: Turbine Hall interior with Boiler Hall behind (2024)

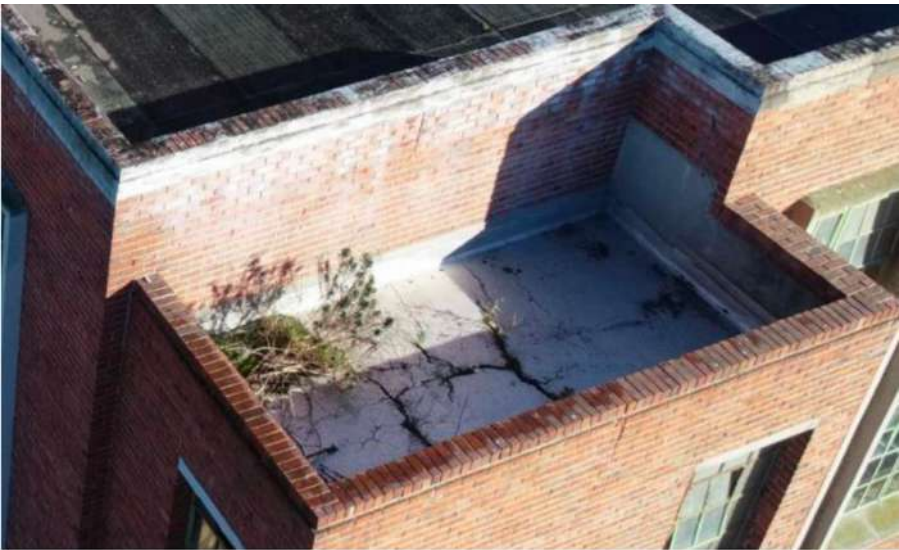
Figure 44: Turbine house flat roof (Esterhuyse, 2020)
